**SUMMARY:**

This report covers TWO work days, as the Depot was active on Friday, 16 June (Public Holiday) as well as the usual Saturday on 17 June. As we were running a train on Sunday, some of our members spent THREE days in a row working at Reefsteamers. Because of the Sunday run, Saturday was fire lighting day and the training opportunity was given to some of our young guys to bring the big 15F into steam.

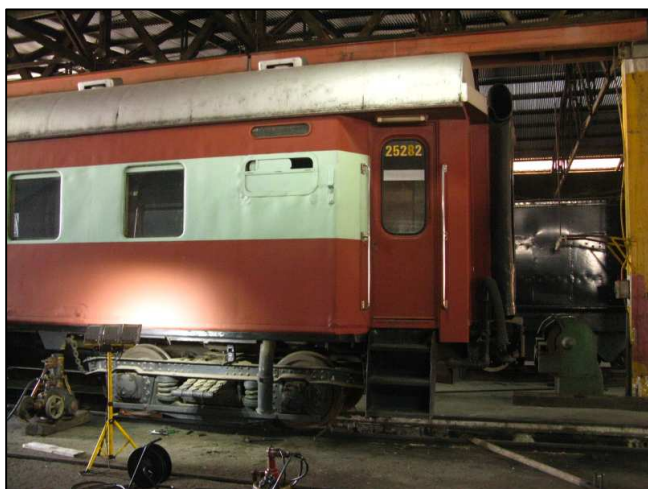
P01 - Locomotion No. 25282 now is about ready to be moved to Bloemfontein – but was being awkward today.

- The original bogie was inspected, oiled and serviced. (The donor bogie had been done before begin fitted.)
- The coach had bolster pivot shims refitted as it was riding too high at one end. Thus, both ends were lifted and lowered on the same day. The coupler heights were measured with an original purpose-made gauge made for the 230 size couplers.
- The brake pull rods and links were installed for the donor bogie – needing modification, mixing and refitting as parts were mismatched. The bent secondary pull rod was straightened as well.
- The axle bearings were pumped with CLS EP2 high pressure red grease.
- The vacuum brake pipe dummies were realigned to the brake pipes.
- The four corner safety chain brackets for the donor bogie had to be re-drilled before being refitted.
- The vestibule steps were refitted. (They had been removed to withdraw the bogie.)

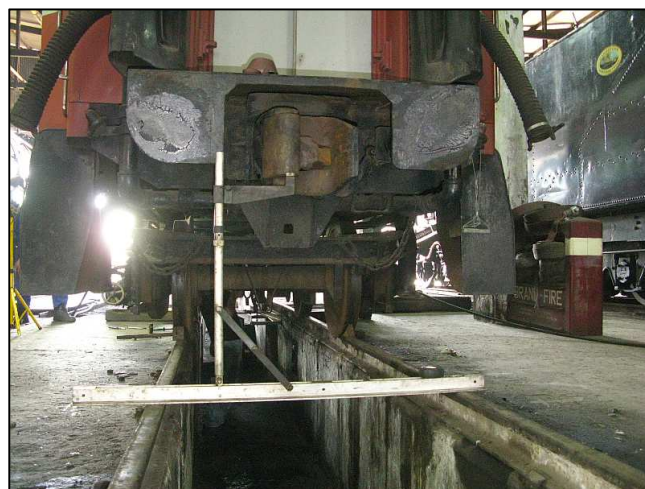
P02 - An original coupler height gauge in use to get the ride heights standardised on the Locomotion Coach.

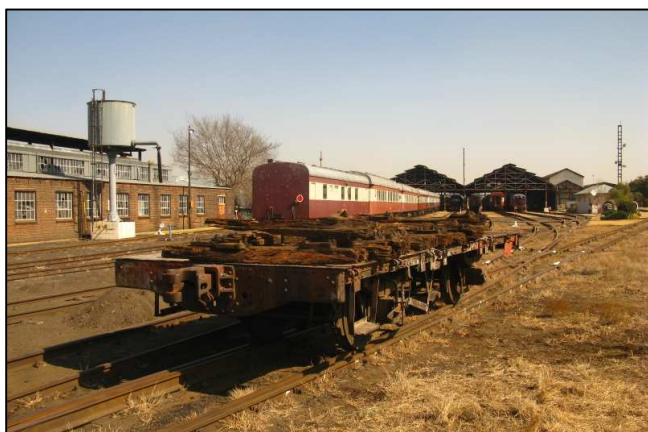
P03 - Some of the rotted wooden sleepers removed from the old staging yard and replaced with concrete sleepers.

- Numerous rotted wooden sleepers have been removed in the locomotive staging yard and replaced with Concrete Sleepers fitted with Pandrol Clips.
- Coenie Gildenhuys has drawn an accurate scale track\building plan for the entire depot and surrounding tracks in Corel Draw and will be using that for visitors, and to indicate the location of Fire Fighting and First Aid Facilities.

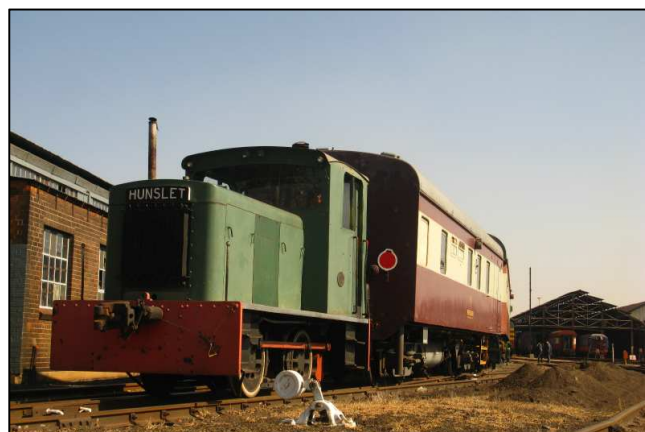
P04 - Recently certified Hunslet Driver Dennis Edgar did a LOT of shunting over the double-day work weekend.

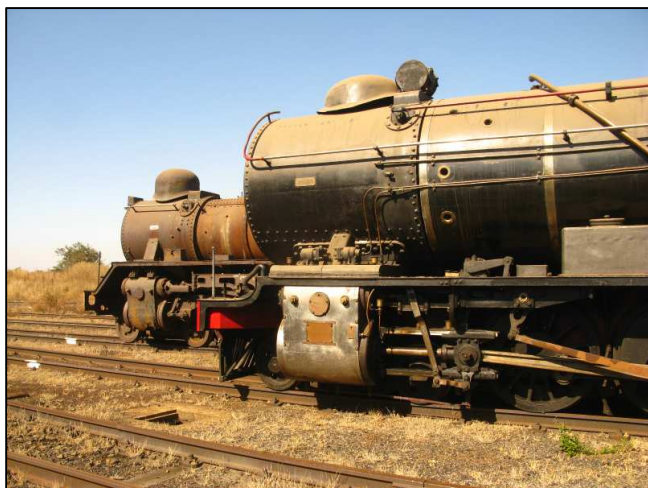
P05 - Awaiting some 15F-powered steam haulage ... two of the heavy shunts for the day, 12AR 1535 (Foreground) and 19D 2540. (The little Hunslet Taylor diesel can't get big steamers like these up the sloped track beyond.)

- Still using 15F 3046 as shunter, ex-Millsite 19D 2540 was moved up to the Carriage Shed.
- 12AR 1535 was shunted out and turned around for access to a three-phase welding plug for her smokebox welding repair project to commence this week.

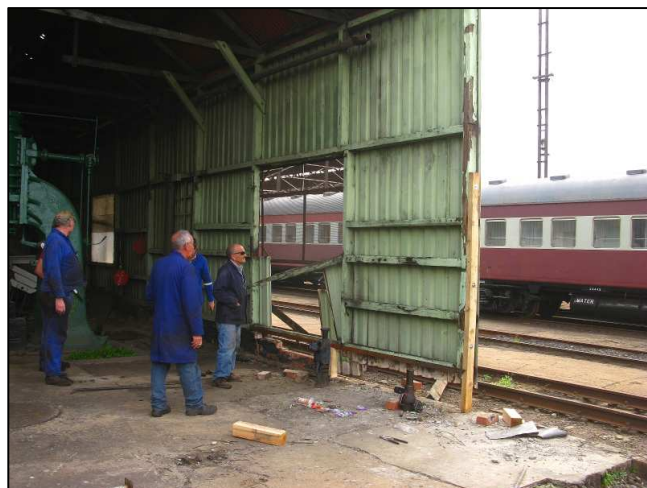
P06 - Some jacking, bracing and repair work taking place on the old forge building. One loose panel was completely removed so the building is now shorter. This isn't part of the original 1885 work, but those timbers are old enough!

- The loose end bay wall of the Forge House was neatly cut away, and the remaining walls given a new heavy timber sill plate, wooden piles, a heavy window sill and diagonal bracing. It is now safe, rigid and ready for the coming summer season.

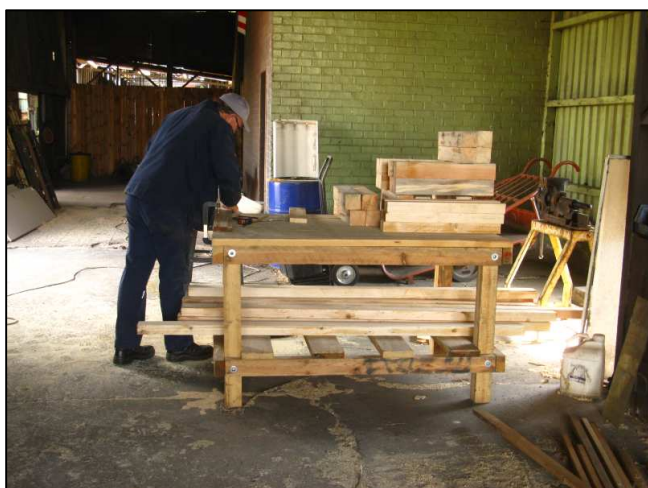
P07 - Hannes Bester is seen cutting and shaping timber for equipment racks for the 15CA 2056 painting project. That is the second wooden workbench he had built on behalf of Reefsteamers.

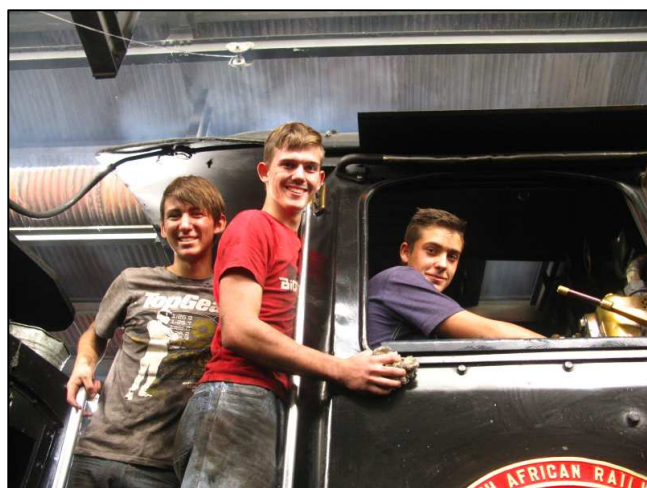
P08 - The RS 'Dirty-Dudes' did themselves proud on Saturday in thoroughly cleaning the 15F 3046 for her Father's Day run. The Dillo (Trying to look dignified on the Driver's Seat) was the main fire lighter for the day.

- Class 15F 3046 'Vreni' was lit up and cleaned on Saturday.
- The cleaning was primarily done by our three regular young men – the Reefsteamers 'Dirty-Dudes.'

- 15yr. old Dylan van Zyl (aka 'The Dillo') was in charge of fire-lighting. (Supervised, of course.)
- The 15F's new compressed air blower connection wasn't as successful as we hoped. The apertures in the built-in blower ring on the blast cap are too large for the air flow available, and the resulting air flow dissipates in the firebox rather than driving a draft up the petticoat.
