SUMMARY:

A shorter work day today as our first Open Day 2017 Planning Meeting was held in the morning.

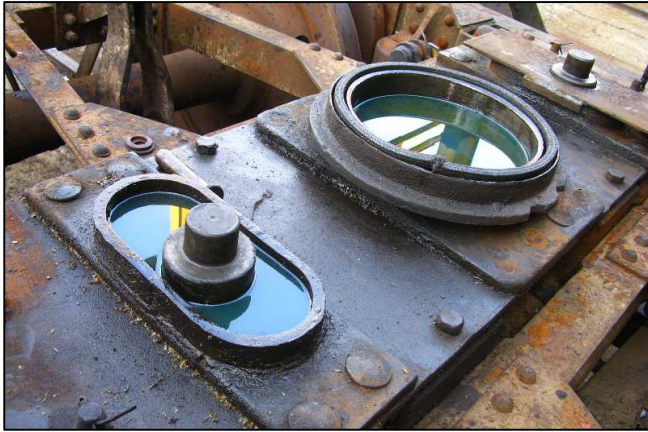
P03 - The newly repaired boss now holds oil as designed. Square-section graphite packing was installed as a seal.

- The ‘cracked’ boss on the Locomotion Coach bogie was actually gouged by the wear washer and oil was leaking through the pores of the cast iron. It was pre-heated and welded to seal the cup.

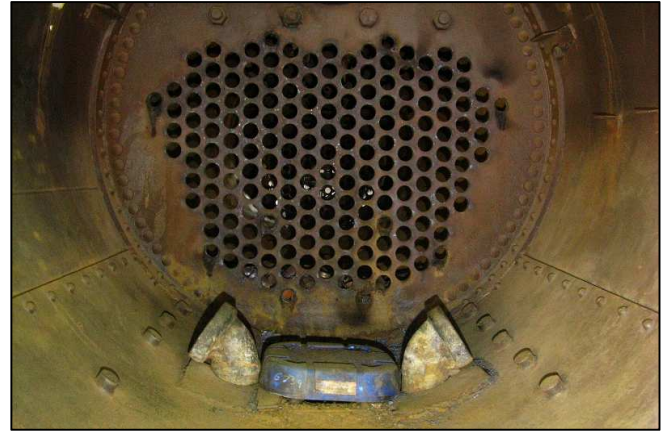
P04 - Class 6A 473 Charlotte's simple front tube plate after having had all the boiler tubes removed.

- Class 15F 3046 ‘Vreni’ was pulled out over the ash-pits and given her routine smokebox clean, and the first half of a boiler washout. (We ran out of time.)
- Class 6A 473 ‘Charlotte’ had had all of the boiler tubes withdrawn during the week. The job was a difficult one as the tubes had been over-expanded and were bulging behind the plates.
- David Shepherd’s 15F 3052 has yet not had accident repair work done, but inspection is due this week. Regardless of visible damage, the axles need to be crack tested anyway.
- 15F 3052’s Brake Ejector had swapped been for FotR’s similar unit from their 19D as the original had failed. The temporary replacement has been removed and will be swapped during the week.

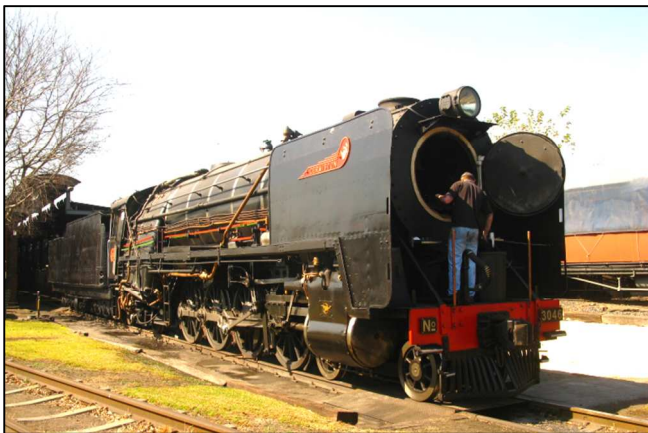
P05 - 15F 3046 Smokebox washout in progress. This was a young people's project today done by Aidan and Kevin.

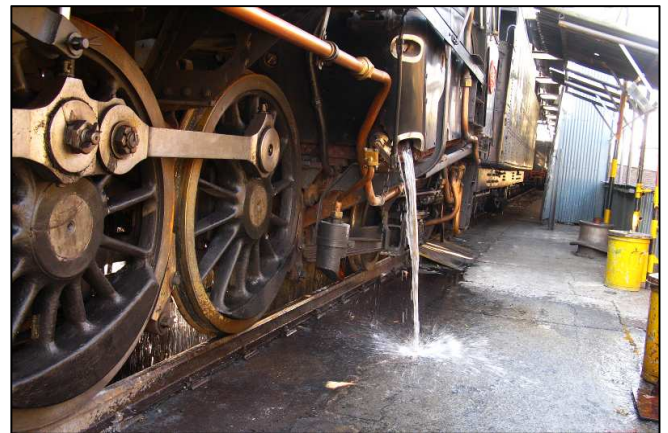
P06 - Early stage of boiler washout in progress. The fellows had yet to start raking out the foundation ring area.

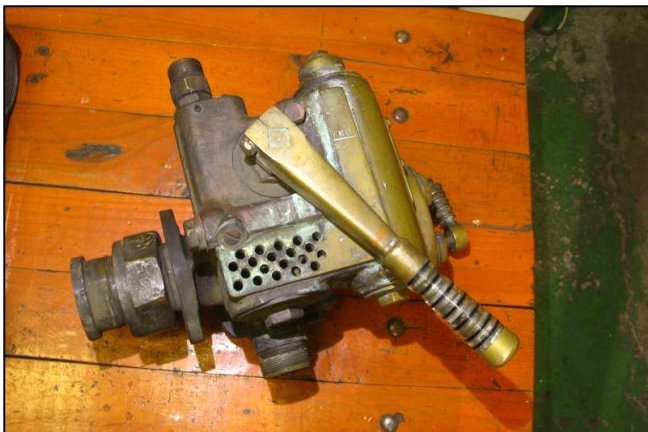
P07 - Brake Vacuum Ejector on its way back to FotR and 15F 3052's faulty unit to be returned.

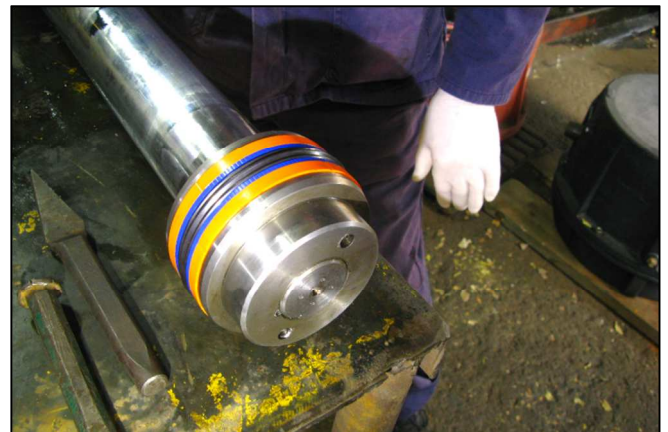
P08 - Brightly coloured hydraulic seals and spacer rings being installed for the extension boom of the coal grab.

- The extension boom’s hydraulic cylinder (The ‘elbow’ joint) has had a full set of seals, spacers and wipers fitted and remains to be reinstalled by the Africa Academy lads.
