**SUMMARY:**

CLASS 15F 3046 'VRENI':

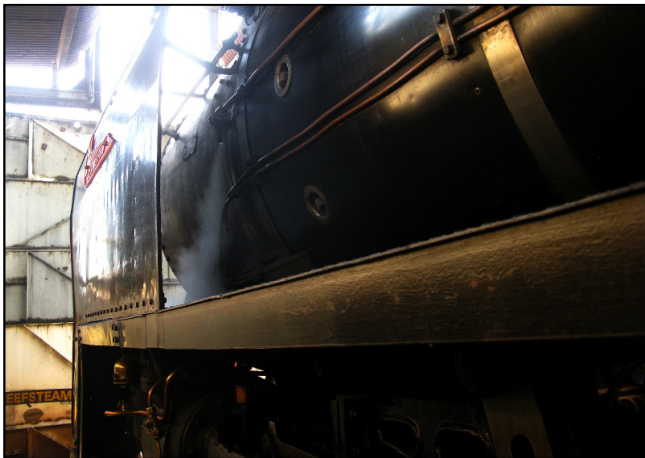
P01 - 15F 3046's new external compressed air connection for the built-in draft ring blower. (Here it was being used for a slow, controlled boiler depressurisation.)

- We normally let boilers depressurise naturally and the slower, the better. But a feed water clack valve needs attention, which meant the boiler needed to be depressurised completely and the latent heat of the water discharged. We let it simmer down very slowly through a slightly open blower valve.

- A compressed air line coupling and valve have been added to the blower lines which means we can use the locomotive's built-in blower ring during fire lighting, instead of the hook & ring blowers that must be lowered into the chimney. (The latter are clumsy and can be hazardous to use as they involve climbing) It was successful and we now plan to bring the line lower to be reached from ground level.

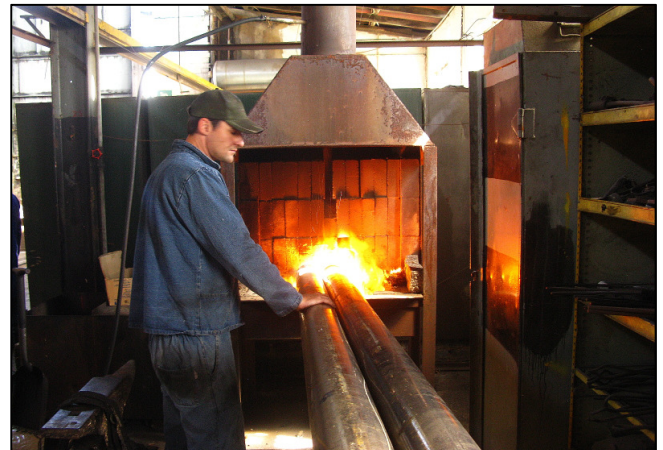
P02 - The 15CA's new boiler flues being heated in the forge for annealing. These would be left alone to air cool. We had four youngsters moving these with woven slings

- Another batch of super-heater flues were heated in the anthracite-fueled forge and left to air-cool for annealing. Each flue tube must go through the process twice. The cut-down end need to be done and then the processed end must be done again after it has been swaged.

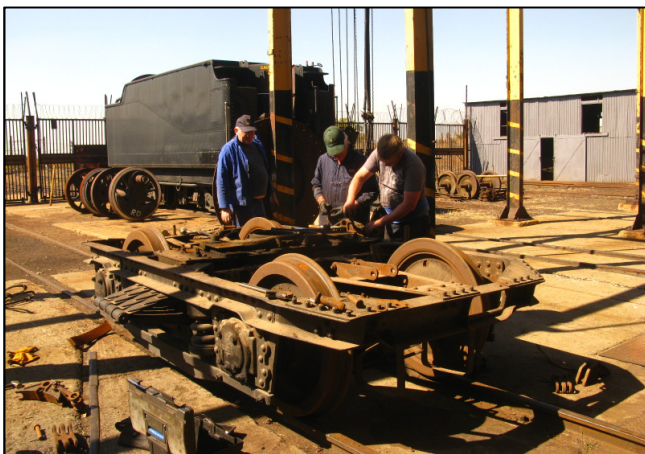
P03 - A donor bar frame-style bogie being serviced and upgraded to be used under Sandstone's Locomotion Coach. (Which will be moving to Bloemfontein soon.)

- The replacement bar frame bogie (from a derelict line inspection coach) has had the partially incomplete brakes consolidated and converted from the old 8-shoe cast iron brake shoe pattern, to an inboard 4-shoe pattern. This is standard practice to match the braking effort of modern coaching stock fitted with four inboard composite brake shoe assemblies.

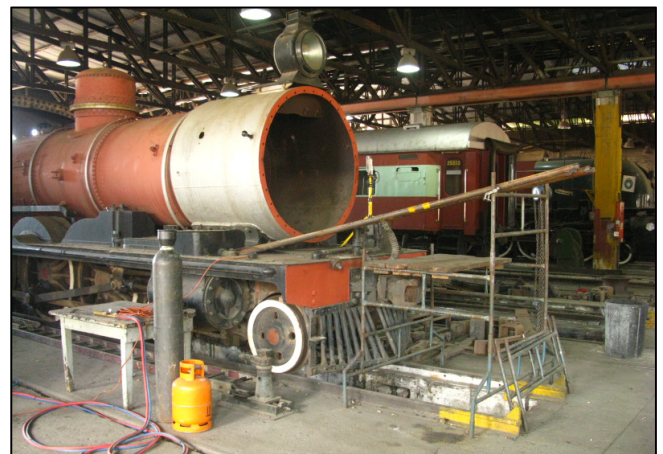
P04 - Class 6A 473 'Charlotte' with the first few boiler tubes having been withdrawn. The other tubes had already been split and crushed at the front end.

- The project of pulling out the boiler tubes has commenced. The entire boiler was re-tubed by SANRASM and those tubes have never actually seen service. However, the tubes have been safe-ended (Joined with an annular weld) and we cannot certify the quality of the weld. So, they are going to ALL be replaced any to be on the safe and professional side.
