**SUMMARY:**

CLASS 15F 3046 'VRENI':

CLASS 15CA 2056 'INGE':

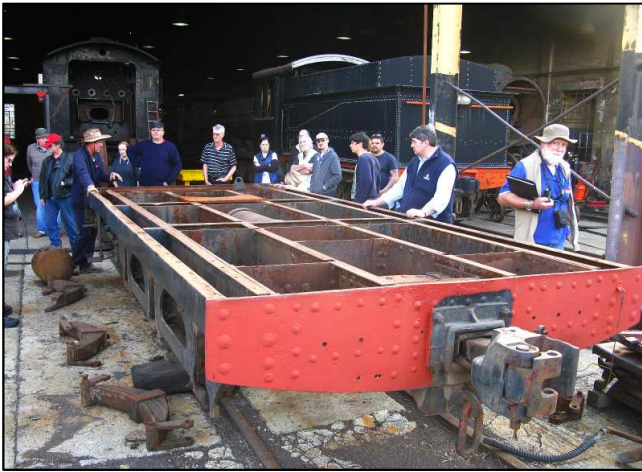
P01 - Our first RED tour group are being shown what a late 19th century tender frame looks like.
